# An Investigation of the Therac-25 Accidents

Nancy G. Leveson, University of Washington

Clark S. Turner, University of California, Irvine

**A thorough account of the Therac-25 medical electron accelerator accidents reveals previously unknown details and suggests ways to reduce risk in the future.**

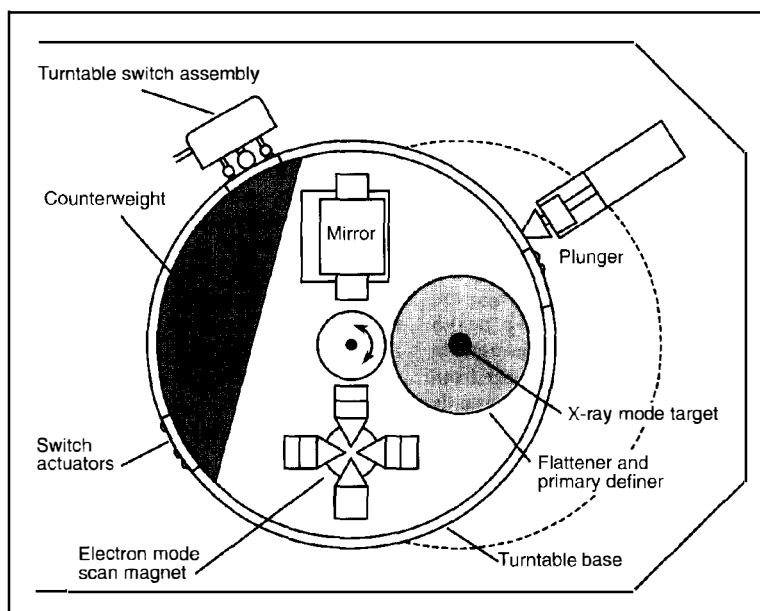
Figure B. Upper turntable assembly.

crossswitch codes (which could be caused by a single open-circuit fault on the switch lines) could produce an ambiguous position message for the computer.

hazard of dual-mode machines: If the turntable is in the wrong position, the beam flattener will not be in place.

No accelerator beam is expected in the field-light position. A stainless steel mirror is placed in the beam path and a light simulates the beam. This lets the operator see precisely where the beam will strike the patient and make necessary adjustments before treatment starts. There is no ion chamber in place at this turntable position, since no beam is expected.

cate turntable position that tolerated a 1-bit error: The code would still unambiguously reveal correct position with any one microswitch failure.

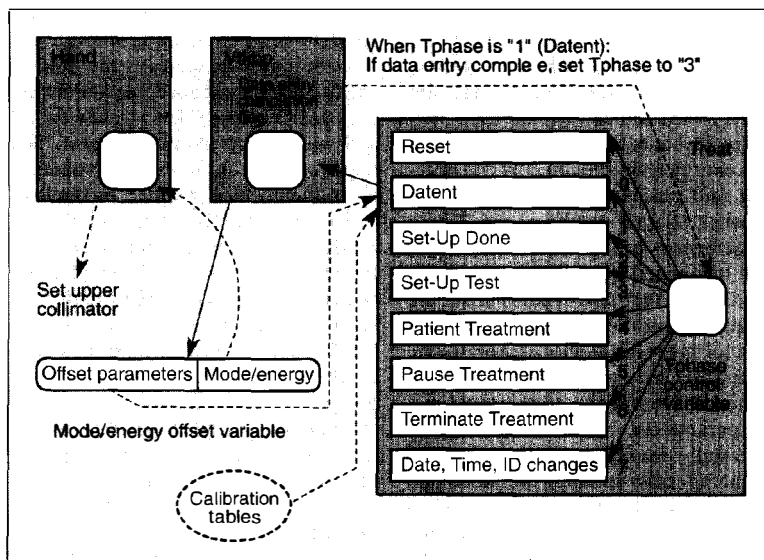
**Figure 2. Tasks and subroutines in the code blamed for the Tyler accidents.**

One of Treat's subroutines, called Datent (data entry), communicates with the keyboard handler task (a task that runs concurrently with Treat) via a

shared variable (Data-entry completion flag) to determine whether the prescription data has been entered. The keyboard handler recognizes the completion of data entry and changes the Data-entry completion variable to denote this. Once the Data-entry completion variable is set, the Datent subroutine detects the variable's change in status and changes the value of Tphase from 1 (Data Entry) to 3 (Set-Up Test). In this case, the Datent subroutine exits back to the Treat subroutine, which will reschedule itself and begin execution of the Set-Up Test subroutine. If the Data-entry completion variable has not been set, Datent leaves the value of Tphase unchanged and exits back to Treat's main line. Treat will then reschedule itself, essentially rescheduling the Datent subroutine.

Upon exit from the Magnet subroutine, the data-entry subroutine (Datent) checks the data-entry completion variable. If it indicates that data entry is complete, Datent sets Tphase to 3 and Datent is not entered again. If it is not set, Datent leaves Tphase unchanged, which means it will eventually be rescheduled. But the data-entry completion variable only indicates that the cursor has been down to the command line, not that it is still there. A potential race condition is set up. To fix this, AECL introduced another shared variable controlled by the keyboard handler task that indicates the cursor is not positioned on the command line. If this variable is set, then prescription entry is still in progress and the value of Tphase is left unchanged.

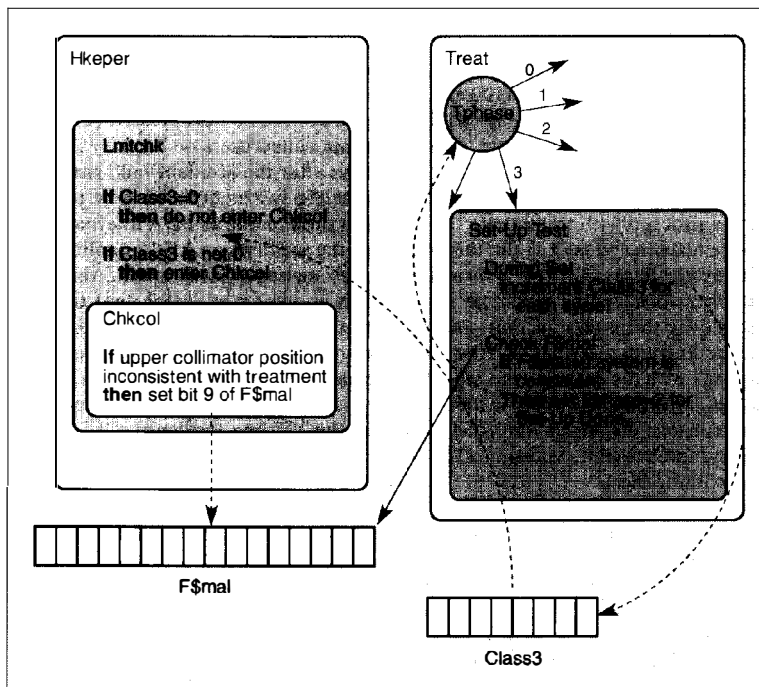
Figure 4. Yakima software flow.

The second Yakima accident was again attributed to a type of race condition in the software — this one allowed the device to be activated in an error setting (a "failure" of a software interlock). The Tyler accidents were related to prob-

lems in the data-entry routines that allowed the code to proceed to Set-Up Test before the full prescription had been entered and acted upon. The Yakima accident involves problems encountered later in the logic after the treatment monitor Treat reaches Set-Up Test.
